INDEX OF TEXAS ARCHAEOLOGY

Investigation and Recovery of USS Westfield (Site 41GV151) Galveston Bay, Galveston County, Texas

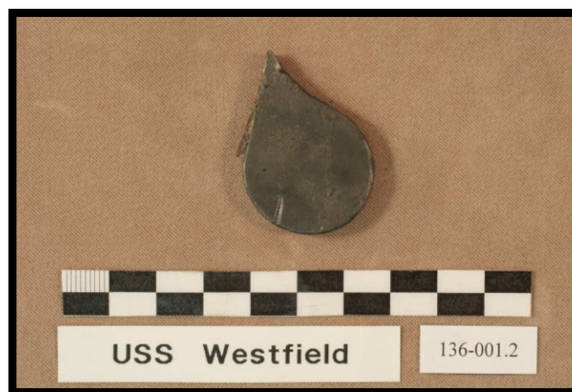
FIGURE 292. SMALL BRASS TAB (ARTIFACT NO. 136-001.6)

A small brass tab (Artifact 136-001.2) was found concreted to a fist-sized chunk of coal (Figure 292). The artifact resembles a finger lever that snapped off from a larger mechanical device. Since coal was found concreted to most artifacts due to *Westfield's* explosion, the artifact cannot be readily associated with something mechanical in the boiler or engine room. How the object was used or from what type of device it came is unclear. The item may have been personal or from a larger piece of shipboard equipment.

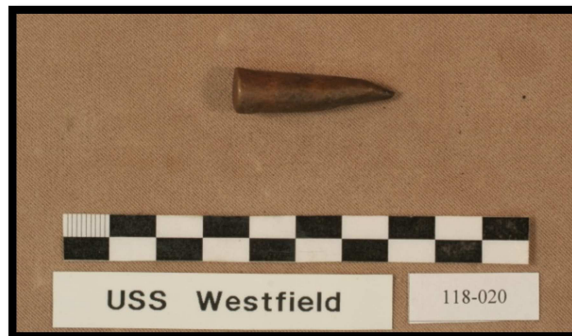
FIGURE 293. SMALL COPPER PUNCH TOOL (ARTIFACT NO. 118-020)

Over 1500 copper tack fasteners were recovered from *Westfield*. These fasteners vary in size since they were all handmade. One supposed tack however (Artifact 118-020), is considerably larger than the rest and does not appear to have contained a head (Figure 293). In general shape, the object is conical. The head may have broken off and the object became weathered and slightly rounded, erasing any evidence. Conservators disagree on whether or not this object was something else, such as a copper punch tool. Rather than weathering and erosion, the rounded head may have been caused by another object striking the head. Additionally, a slight bend at the narrowest point suggests that the object is slightly distorted. This distortion could have been caused due to the soft nature of the metal being used over a longer period of time.

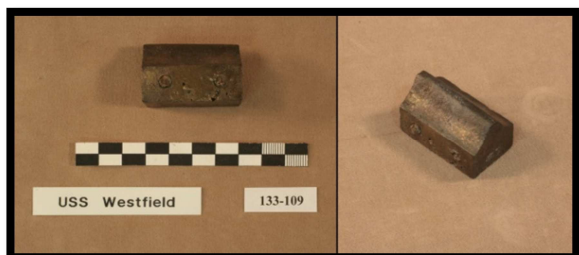
FIGURE 290. UNIDENTIFIED BRASS ARTIFACT - POSSIBLY A GUN SIGHT (ARTIFACT 133-109)

A larger brass artifact is believed by conservators to be a gun sight from a large piece of ordnance (Artifact 133-109). The object has a rectangular lower body, which on top of the longest sides, slopes gracefully upwards into a sight-like ridge (Figure 290). The artifact contains four broken mounting points that appear to contain screws that snapped off inside the object. Without understanding to what the artifact mounted, the use of the object is still considered unidentified.

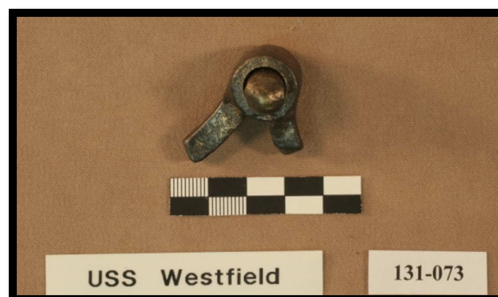
FIGURE 294. POSSIBLE FRAGMENT FROM NAVIGATIONAL SEXTANT (ARTIFACT NO. 131-073)

A rather unique shaped artifact led to much speculation among conservators (Artifact 131-073). The artifact contains two dual arms that radiate out from a reinforced open center (Figure 294). Inside the opening, a heavy pin was hammered on one side to prevent slipping, but is now broken. The reinforced center and the large size of the pin suggest the artifact originally came from a much larger object. Based on the curved shape of the arms, conservators believe the artifact came from a navigational sextant, and that the heavy pin once supported a pivoting telescope. Unfortunately, without more of the object, this theory cannot be confirmed.

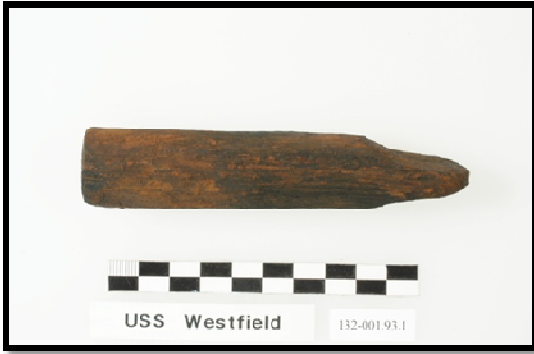
FIGURE 295. SMALL WOODEN DOWEL POSSIBLY USED AS PESTLE TOOL

During the conservation of one of *Westfield's* fire grates, a small wooden dowel-like object was recovered from within the concretion (Artifact 132-001.93.1). The original use of the object is not clear. One of the ends contains two carved out sections that resemble holding points as though for an index finger and thumb (Figure 295). Conservators have theorized that the artifact could have been used as a kitchen stirring tool or a pestle from a grinding bowl.

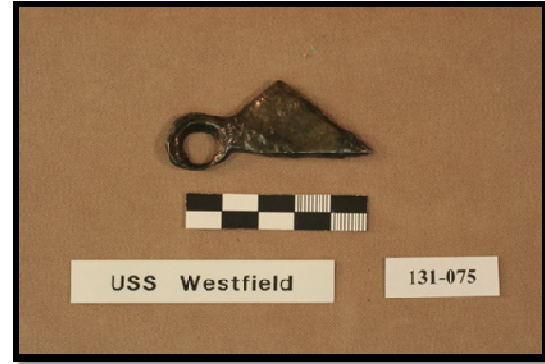
FIGURE 296. SMALL BRASS TRIANGULAR TAG (ARTIFACT NO. 131-075)

One small brass artifact (131-075) resembles a tag that might have hung or possibly rotated as a fitting on a larger device. With the exception of a heavily weathered ring at one corner, this artifact is triangular with angles measuring 45, 45, and 90 degrees (Figure 296). Opposite of the ring, between the upper 90 degree and lower 45 degree angles, the in-between edge has been intentionally sharpened for an unknown purpose. All other edges are rounded.

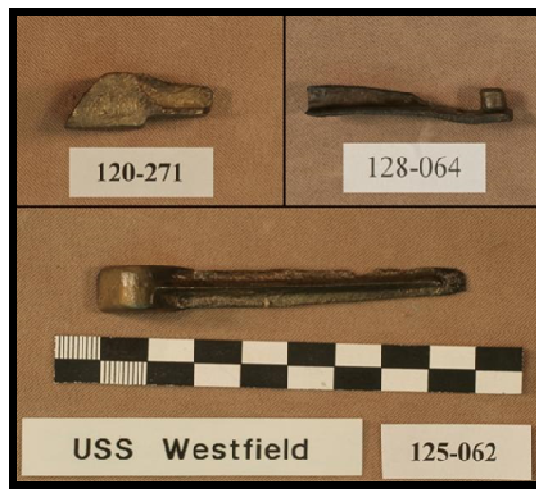
FIGURE 297. UNIDENTIFIED BRASS TABS (ARTIFACT NO. 120-271, 125-062, AND 128-064)

Three artifacts (120-271, 125-062, and 128-064), which all are related in design, still have not been identified (Figure 297). The artifacts are made of brass and reinforced with ridges to prevent bending. Only Artifact 125-062 appears to be complete. The other two artifacts have snapped approximately midway through their original length. Artifact 128-064 contains a button at the end that once clipped onto an unknown object. These objects may have been used in a larger common device.
